Case 244 : Narrative

Case Vehicle (A): 1999 Chrysler
Type: Sebring, 2-door convertible
Driver: 47-year-old male
CDC: 12-FYEW-5

CASE NO.: 244-01

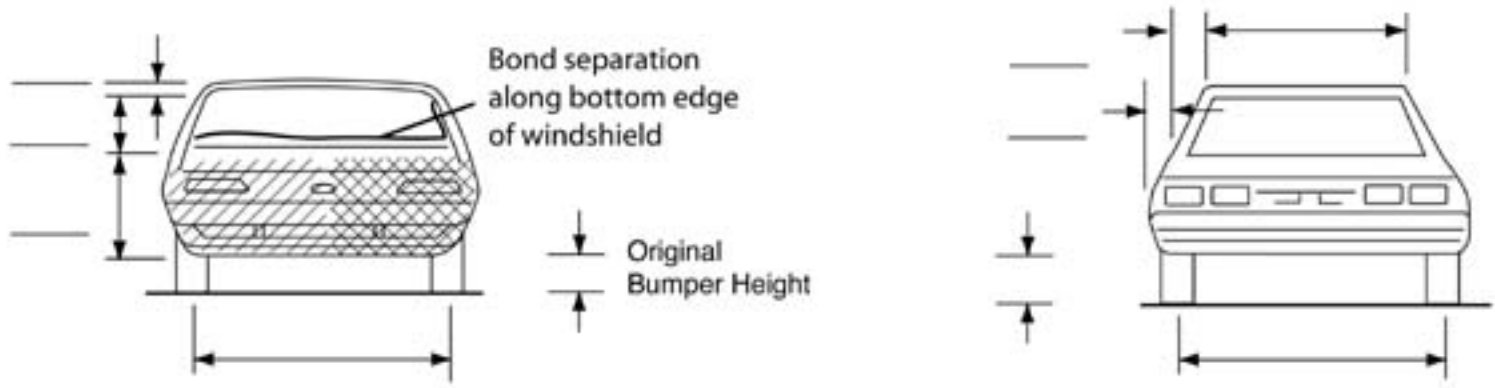
Direct damage
length 62 cm

Max crush = 110 cm

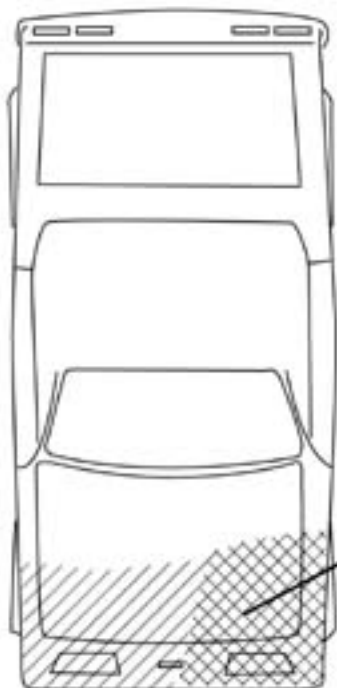
+ 85 degree
steering angle

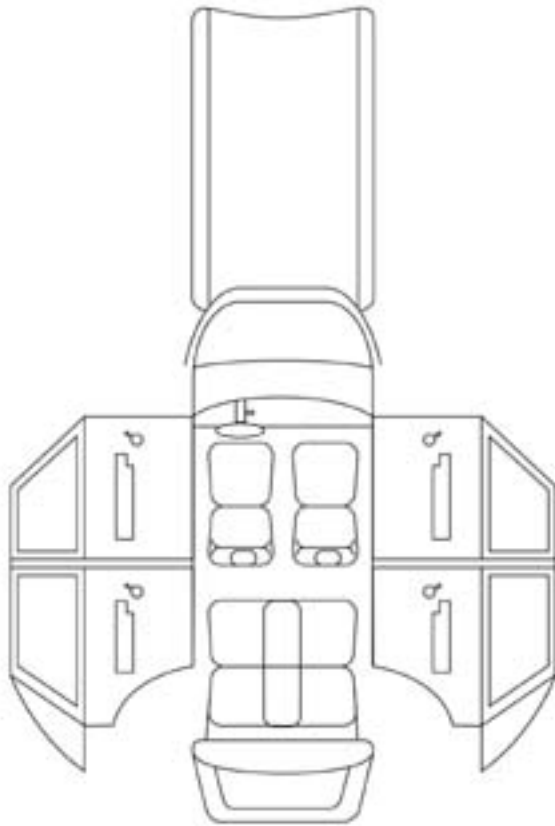
**Hole in face of airbag
with blood deposit**

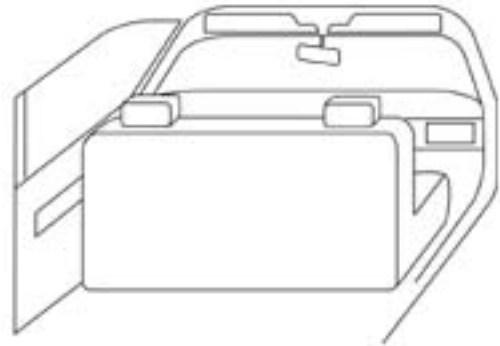
**Cloth transfer and
key broken off
in the ignition**
